REPORT ON COLUMN REPAIR AND CONSTRUCTION

THORSTENSON RESIDENCE 1569 NW 167TH STREET SHORELINE, WASHINGTON 98177-3852

Project:	Final Report for 1569 NW 167th Street, Shoreline, Washington 98177-3852
Attn.:	Mr. Bob Thorstenson
Subject:	Restoring Structural Integrity of the Slab and the pool

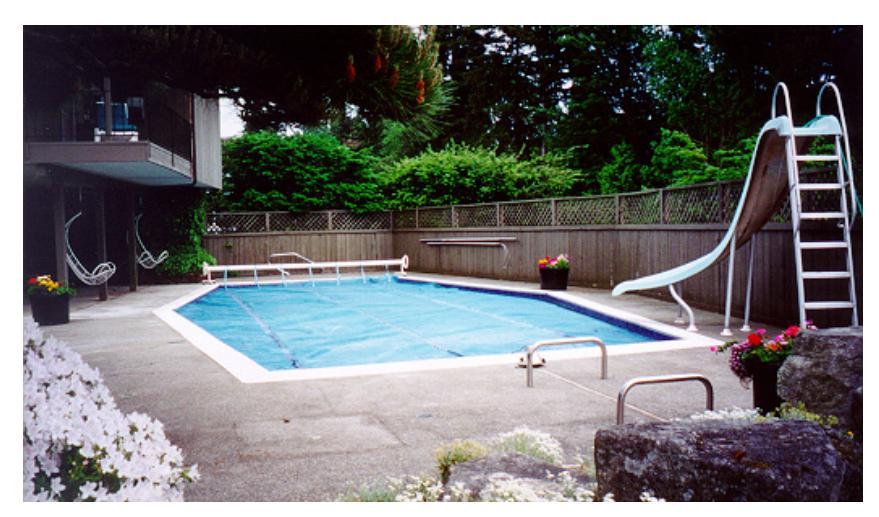
Figure 1: The rear yard

The outdoor in-ground gunite swimming pool is located in the eastern portion of the rear yard, and the surrounding area of the pool is a slab which is partially supported on fill material in conjunction with concrete beams and columns (Figure 1).

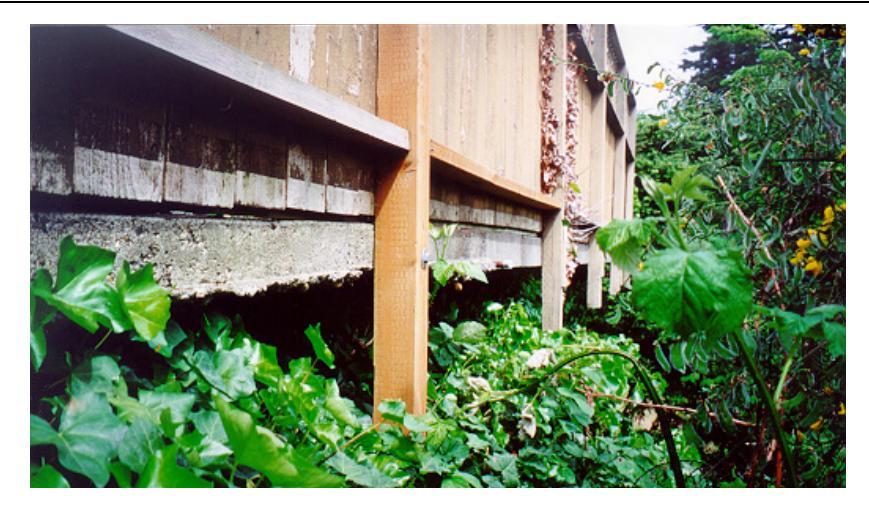
Figure 2: The fence, concrete slab, and the soil erosion

The edge of the slab is fenced and there is a steep slope leading to the Boeing Creek. The fill underneath the slab appears to have suffered from substantial soil erosion, as is evident in Figure 2.

- Long term wetting/drying and freeze-thaw cycles may cause very shallow sloughing failures on the steep slope immediately below the pool. The potential for this activity can be minimized by applying a coat of shotcrete to the slope face at locations where shotcrete does not already exist. Alternatively, planting vegetation on the exposed surfaces will aid in reducing the potential for future erosion and sloughing. The existing English Ivy is considered a nuisance species, but can serve as a protective vegetative cover. Other species can be used, as recommended in the Washington Department of Ecology Publication 93-30 "Slope Stabilization and Erosion Control Using Vegetation" (1993). Excavated pockets in the face of the slope around the piers can be backfilled using Controlled Density Fill, which is a very weak concrete mix that is also called "flowable fill". When cured, it has the consistency of a very stiff cohesive soil, and can be excavated later if needed. Forms will be needed to keep it in place when first poured.

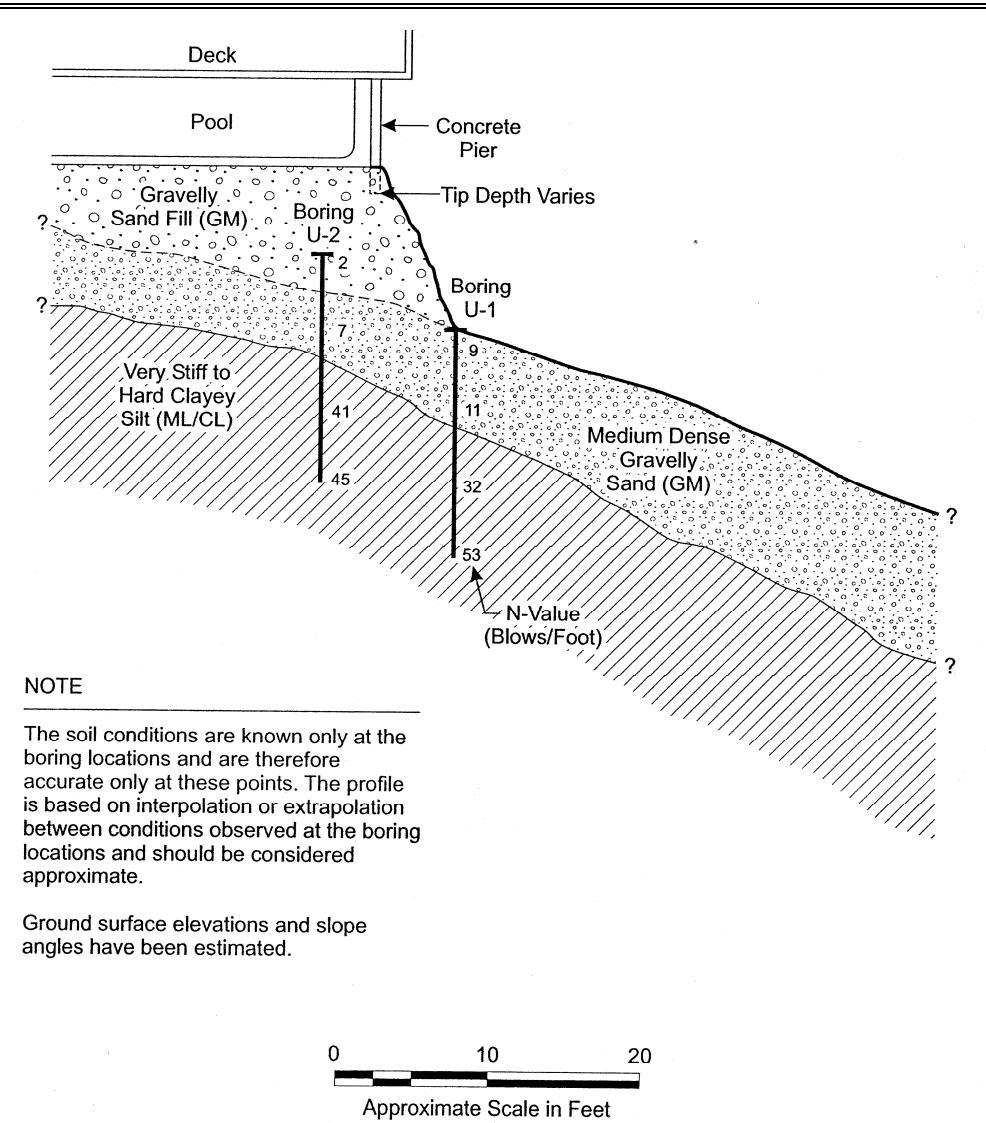
Figure 7: Soil profile beneath the east end of the pool

An estimated soil profile beneath the east end of the pool is shown on Figure 7.

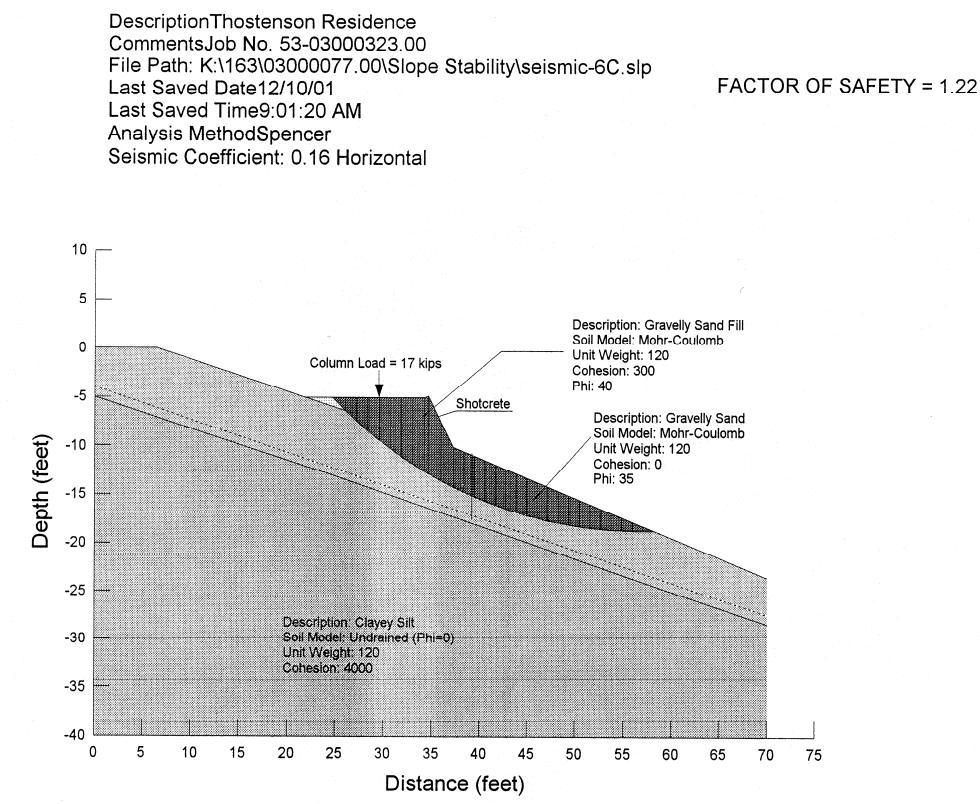
Figure 12: Seismic slope stability analysis, Section B

At Profile B the analysis indicates that an adequate seismic factor of safety of 1.22 is obtained if the full 17 kips of load from the column is applied to the slope (Figure 12).

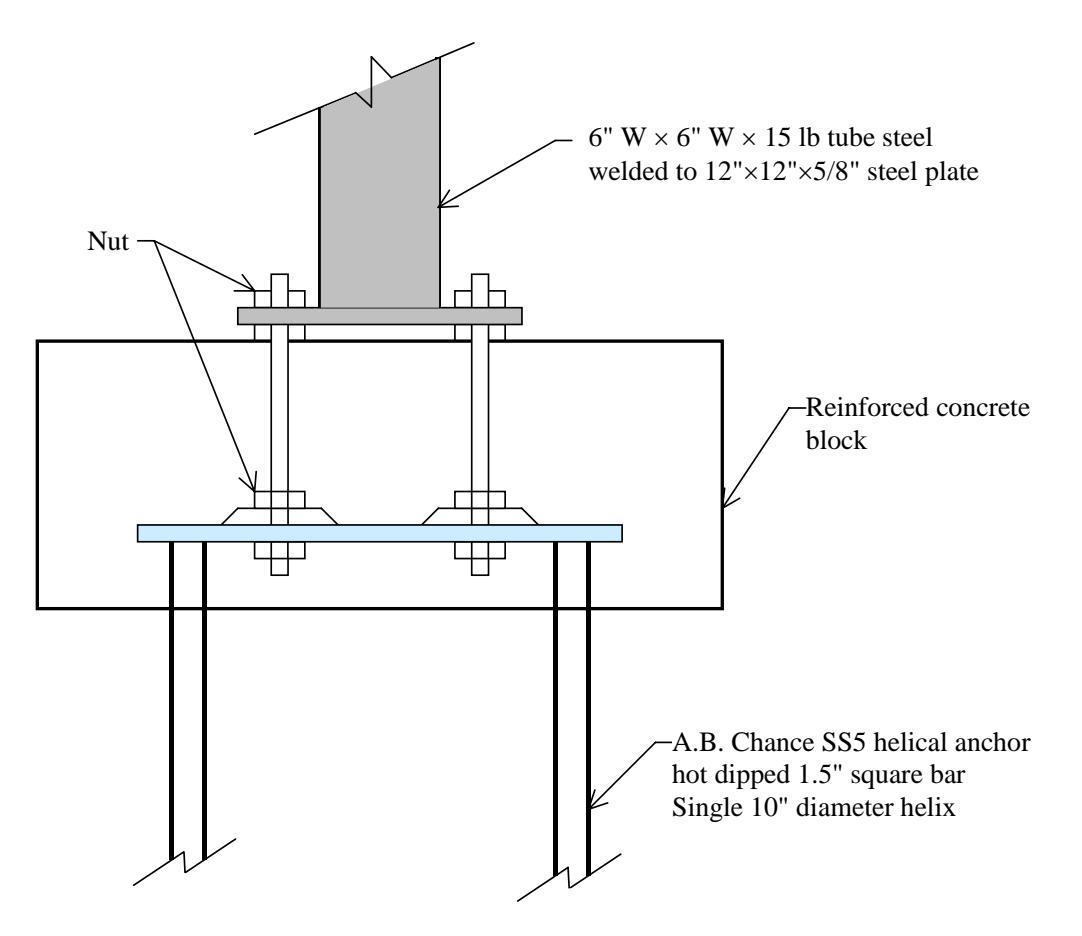
Figure 14: Details of concrete pile cap

Finally, the entire bottom system is boxed in a 24"×24"×12" reinforced concrete pile cap. For reinforcement #4 bars were used 4" O.C. both ways. Figure 14 shows the details of concrete pile cap.

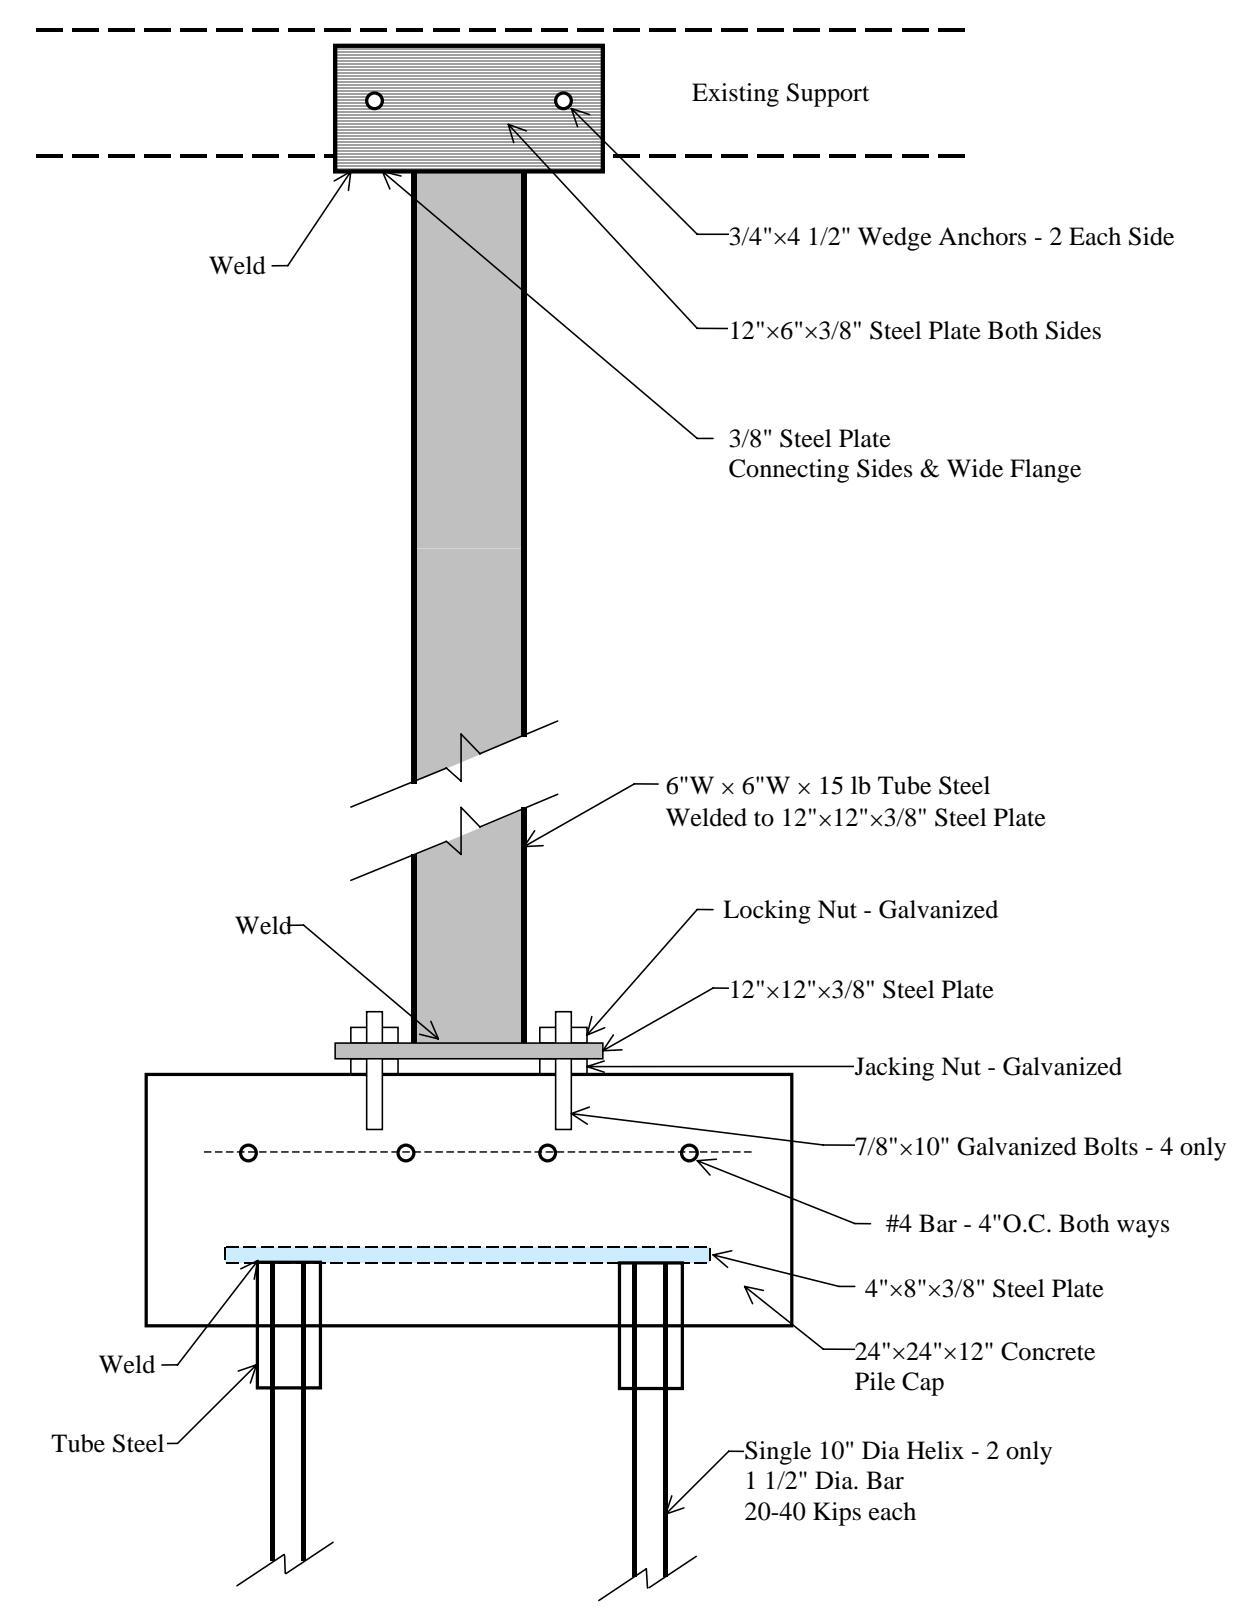
Figure 15: Sketch of the new column and details

Figure 15 shows the sketch of the new column and some of its details

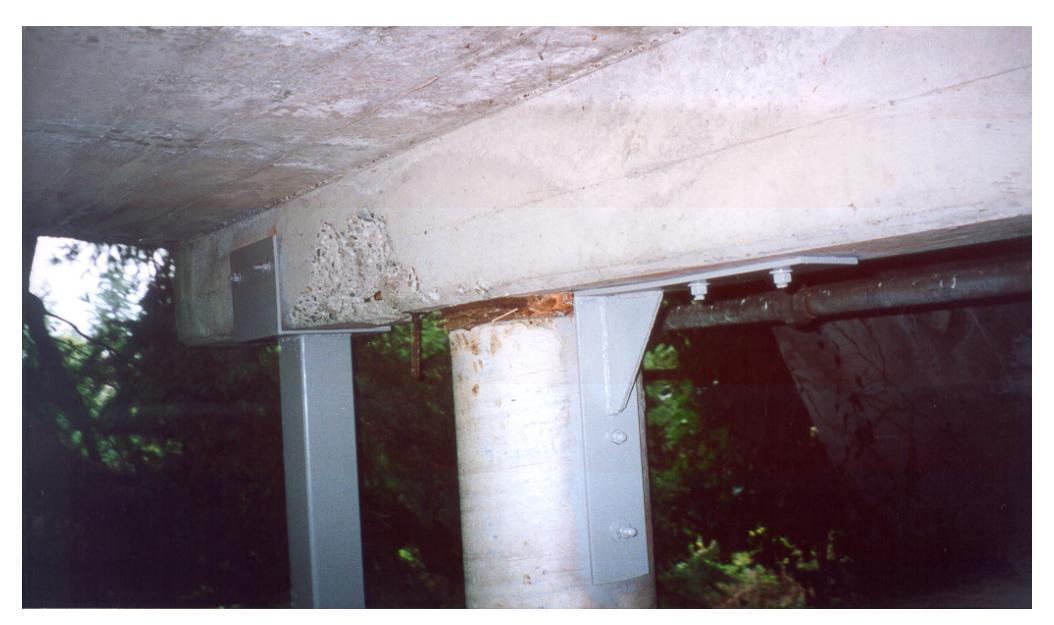
Figure 18: The existing and new columns connected to the beam

Figure 18 shows the top of the new column connected to the existing beam as well as a new bracket physically connecting the existing concrete column to the existing concrete beam.

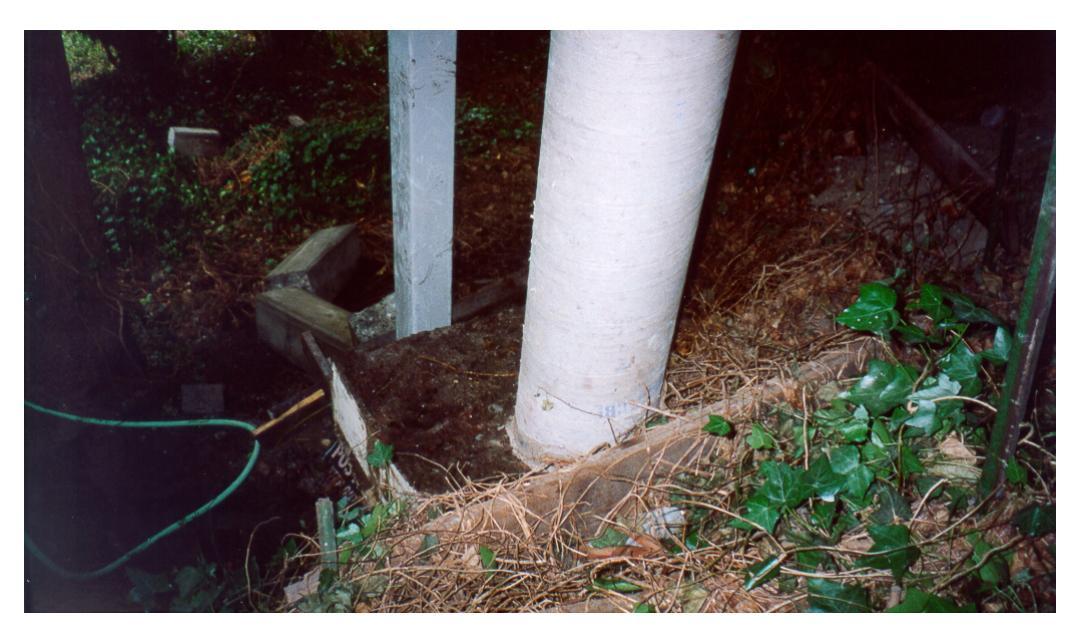
Figure 19: The existing and new columns

Figure 19 shows the existing concrete column next to the newly constructed column.

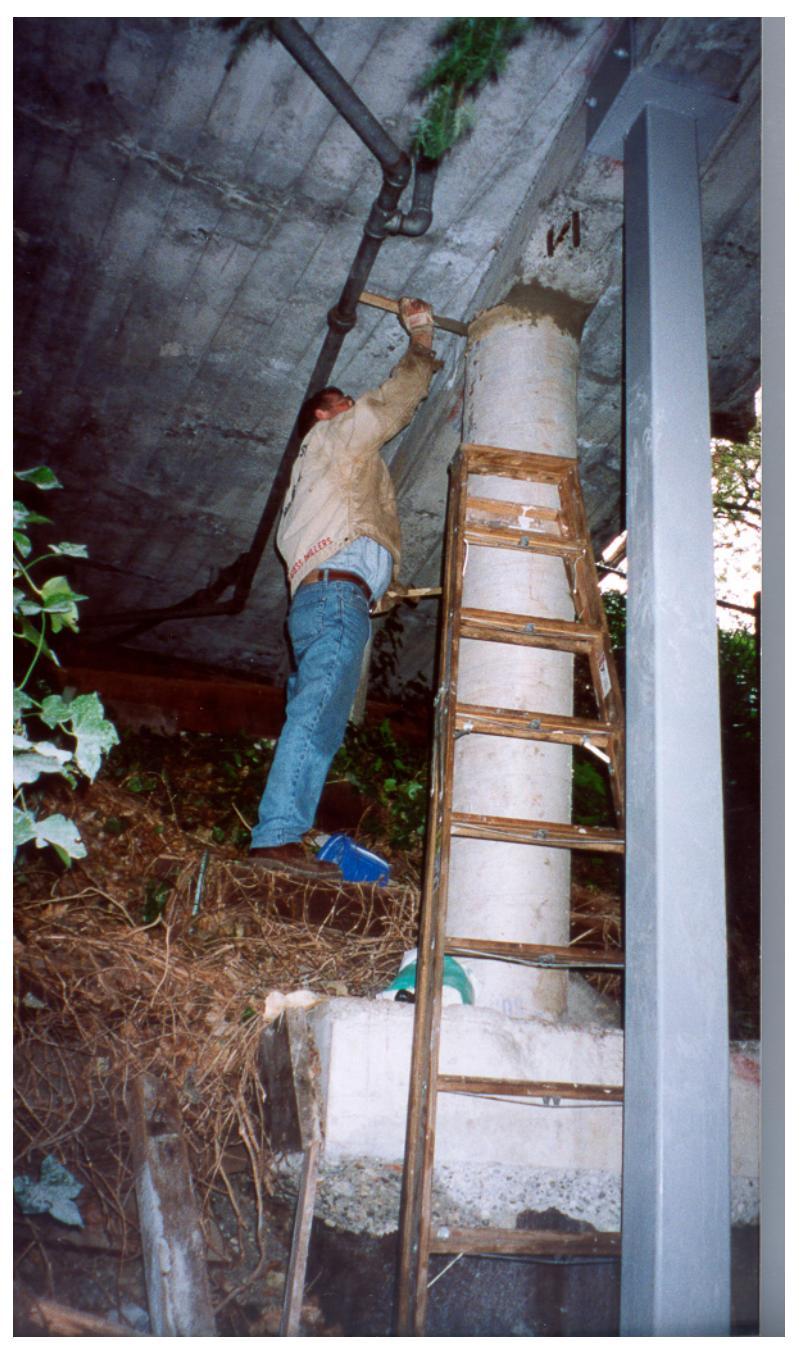
Figure 20: The new column and repair of the existing column

Figure 20 shows the new column and the gap at the top of the existing concrete being filled to make physical connection to the slab above.

The new steel column was primed and painted to resist corrosion. If there are any questions, please feel free to contact me.
