REPORT ON COLUMN REPAIR AND CONSTRUCTION

THORSTENSON RESIDENCE 1569 NW 167TH STREET SHORELINE, WASHINGTON 98177-3852

Project:	Final Report for 1569 NW 167th Street, Shoreline, Washington 98177-3852
Attn.:	Mr. Bob Thorstenson
Subject:	Restoring Structural Integrity of the Slab and the pool

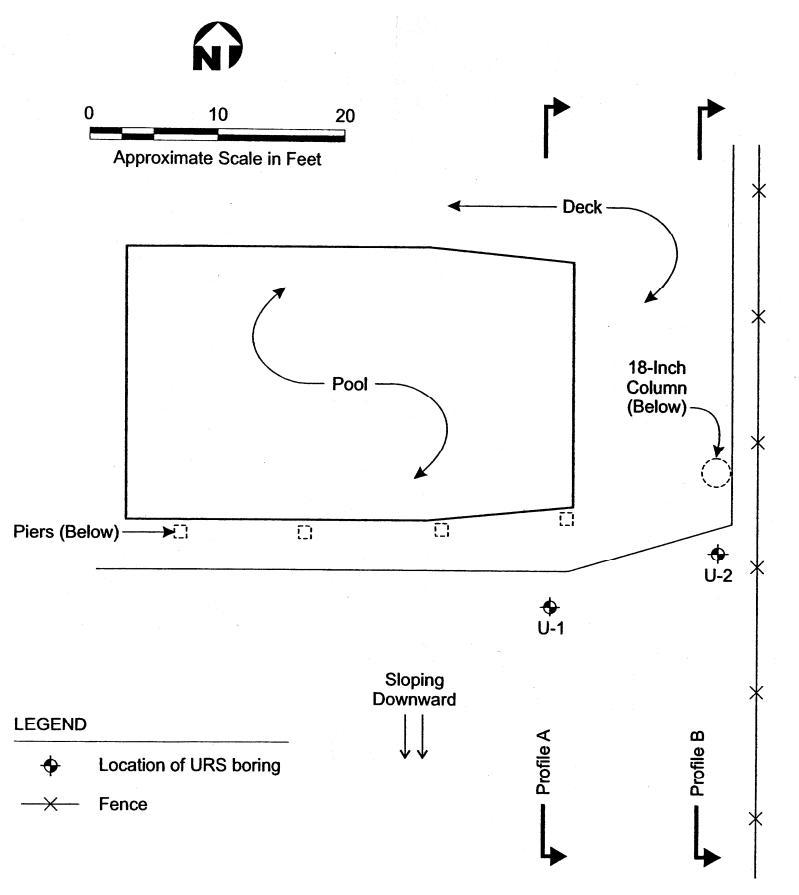
Figure 3: Site Plan

Subsurface soil and groundwater conditions were investigated by drilling two boreholes at the locations shown on Figure 3. Access to drilling sites was limited by low overhead space beneath the deck and steep slope conditions just below the pool itself. The boreholes were drilled using a portable gasoline-powered hollow stem auger to a depth of 15 feet each. Standard Penetration Tests (SPT) were performed using a standard split spoon sampler that was driven by an automatic hammer. Penetration resistance values (N-values in blows per foot) obtained during the sampling process were recorded for use in estimating the engineering behavior of the soils.

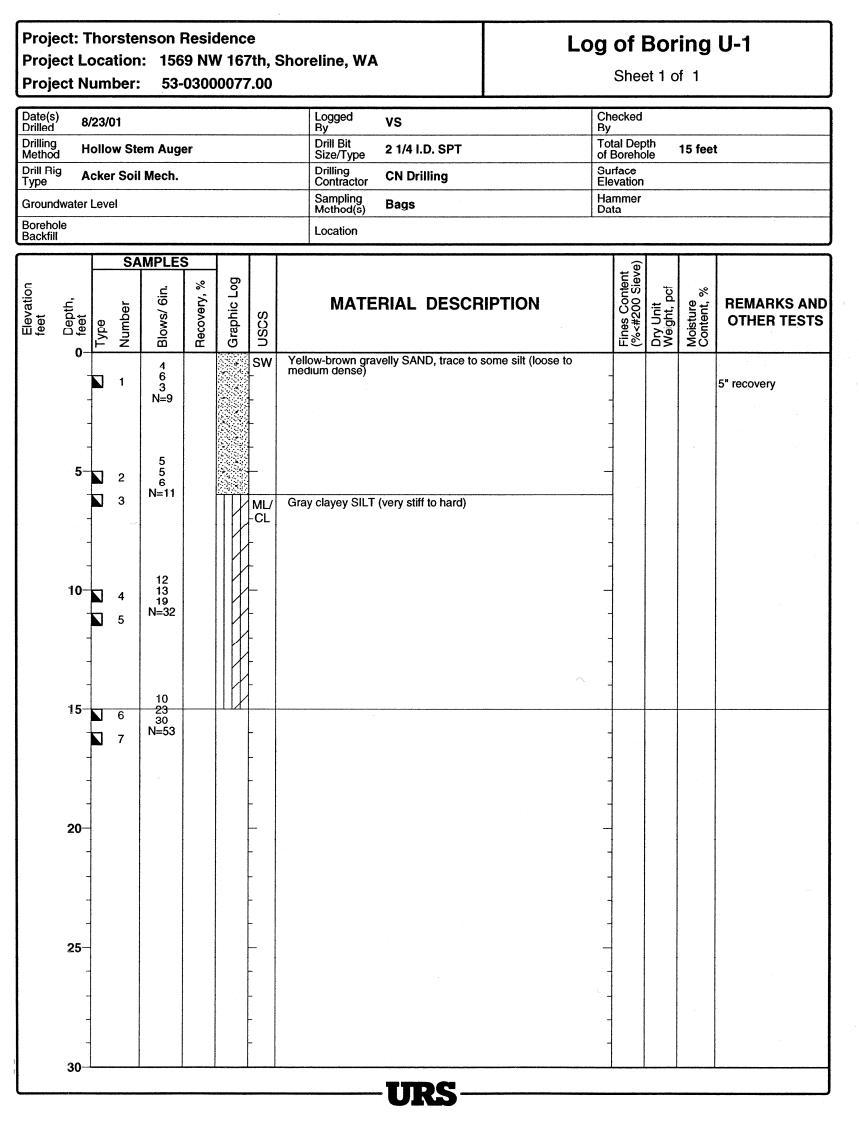
Figure 4: Log of boring U-1

The field exploration was coordinated by a URS representative who located the borings, classified the materials encountered, maintained a log of each boring and obtained samples of the various strata for additional visual examination and future laboratory testing. Graphical representations of the soils encountered in the borings U-1 and U-2 are presented in logs in Figures 4 and 5 (also refer to Figure 3 for the location of borings).

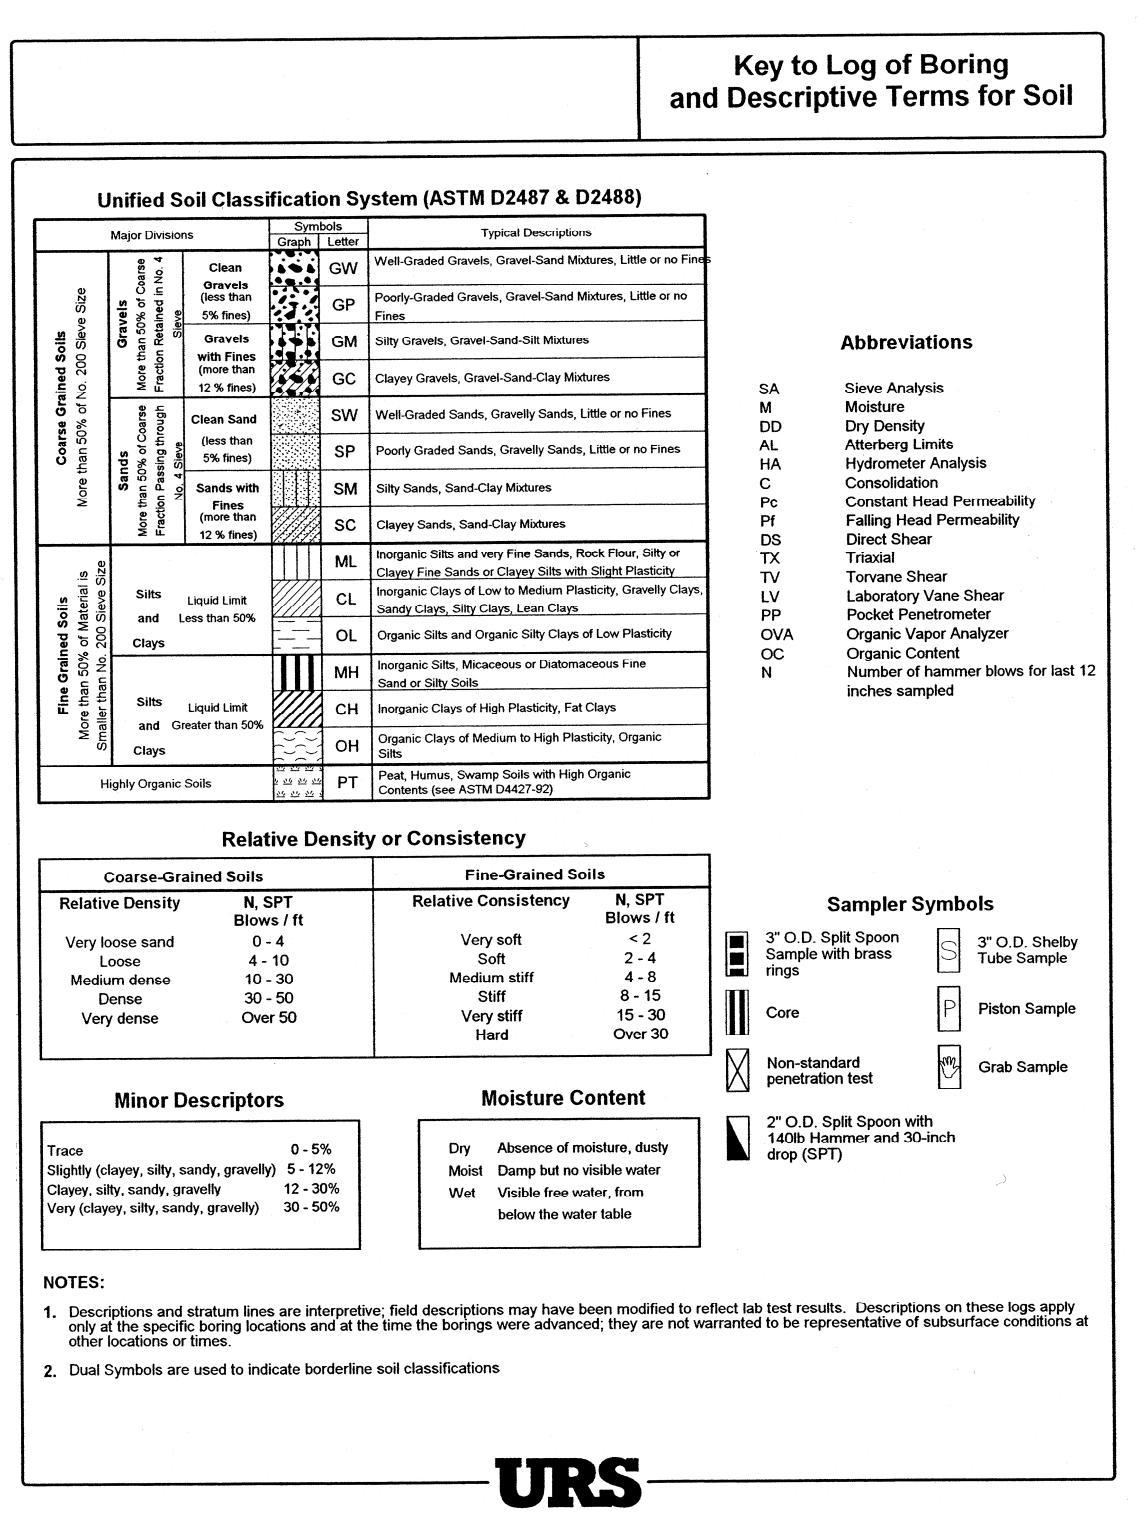
Figure 6: Key to log of boring and descriptive terms of soil

The soils have been classified in general accordance with the Unified Soil Classification System that is summarized on Figure 6.

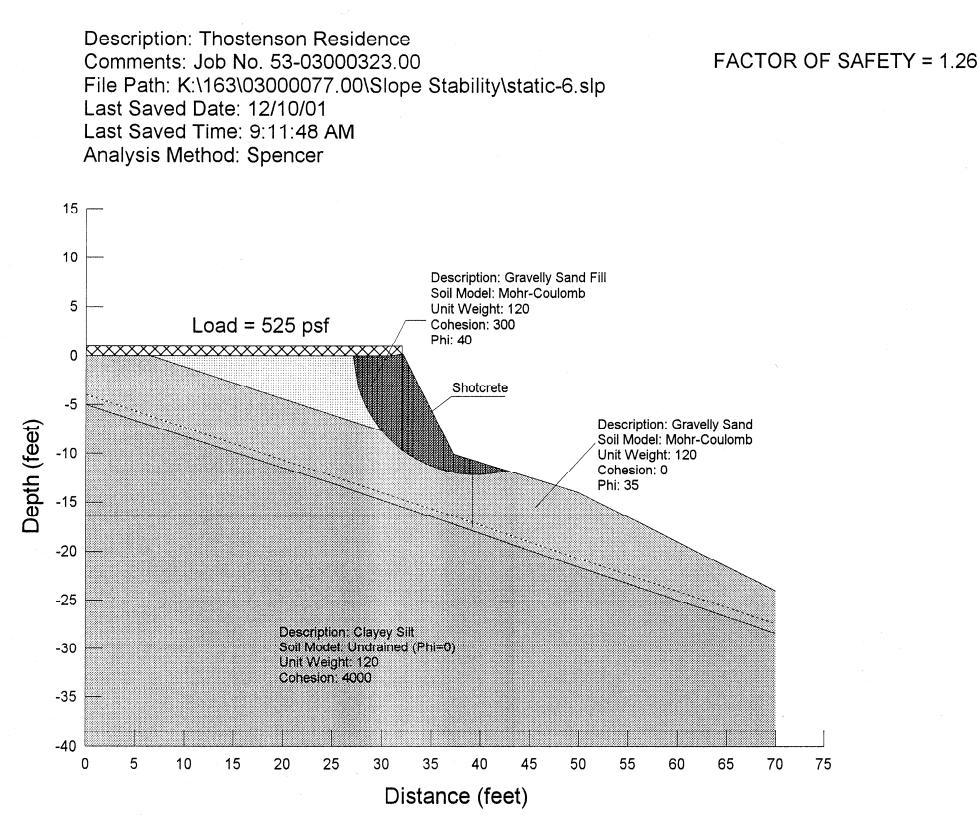
Figure 8: Static slope stability analysis, Section A

Graphical results of the slope stability analyses at Profile A are shown on Figures 8 and 9 for the static loading case and on Figures 10 and 11 for the seismic case. The potential slide mass with the lowest factor of safety is shaded in the figures. The analyses indicated that an adequate factor of safety of 1.56 is obtained for the most realistic "No Surcharge" static loading scenario. The engineering community considers a safety factor of at least 1.5 as adequate for permanent slopes. A factor of safety of 1.26 was obtained for the less-realistic "Surcharge" static loading case. Both the "surcharge" and "No-Surcharge" scenarios resulted in adequate safety factors for the seismic case. The seismic factor of safety of 1.08 for the "Surcharge" scenario is sufficiently close to the desired 1.1 value to be considered satisfactory.

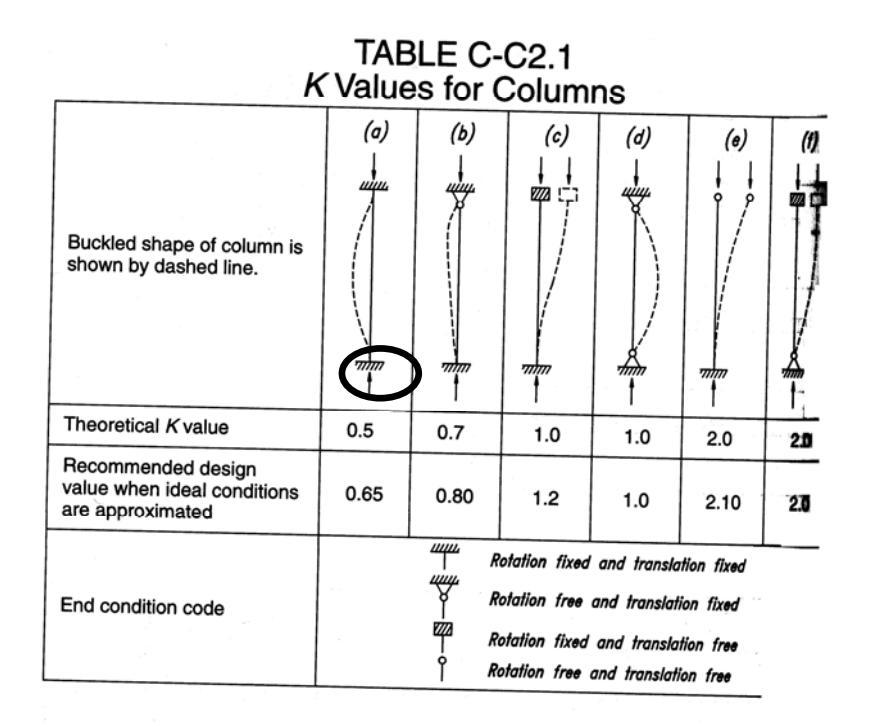
Figure 16: *K* values for columns (from AISC)

From AISC (American Institute of Steel Construction) Manual of Steel Construction, Table C-C2.1, the recommended design value for the K factor for a column with both ends fixed is 0.65.
