Fracture Analysis of Concrete Using Scanning Electron Microscopy

KAMRAN M. NEMATI

Department of Civil and Environmental Engineering, University of California at Berkeley, Berkeley, California, USA

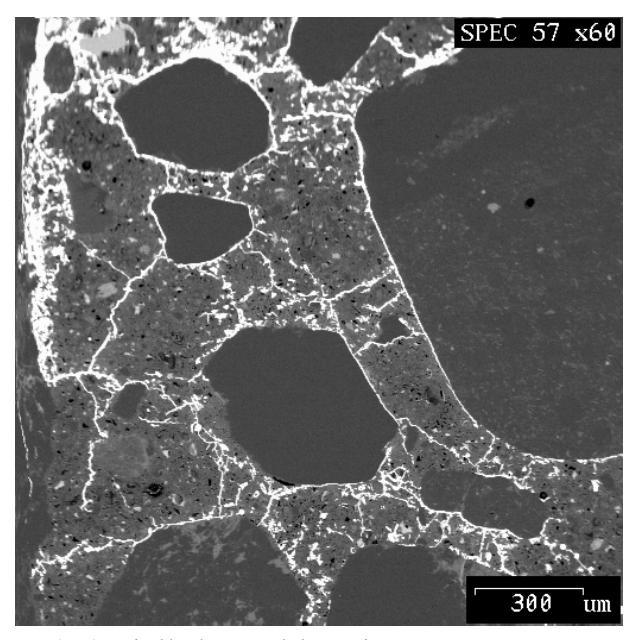
FIG. 1 A typical backscattered electron image.

After the concrete samples were prepared for SEM studies, images were extracted from each sample. A total of four samples taken from the center and edge of the concrete cylinders in axial direction was studied. The images was acquired by the image analyzer at a magnification of $\times 60$ and digitized into an array of 512×512 pixels with 256 gray levels (1 pixel = 3.3 µm). A typical gray level backscattered electron (BSE) image is shown in Figure 1.

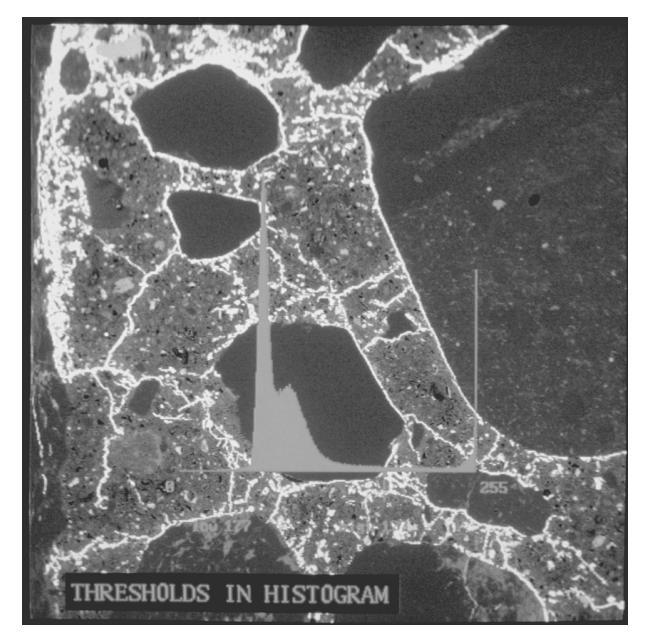
FIG. 2 Establishing threshold in histogram.

Figure 2 shows a histogram of the distribution of gray levels in the BSE image, superimposed on the original image. The peak at the right (high gray level) corresponds to the areas of Wood's metal, while the peaks to the left correspond to the cementitious phases and aggregate. This histogram was used to select the threshold values for discriminating the areas of Wood's metal. Figure 3 is the final binary image used for crack analysis.

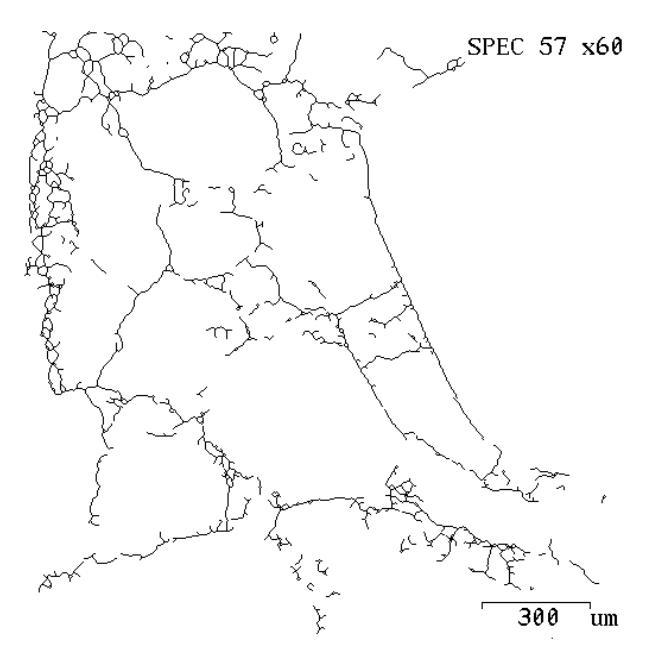
FIG. 3 Crack network.

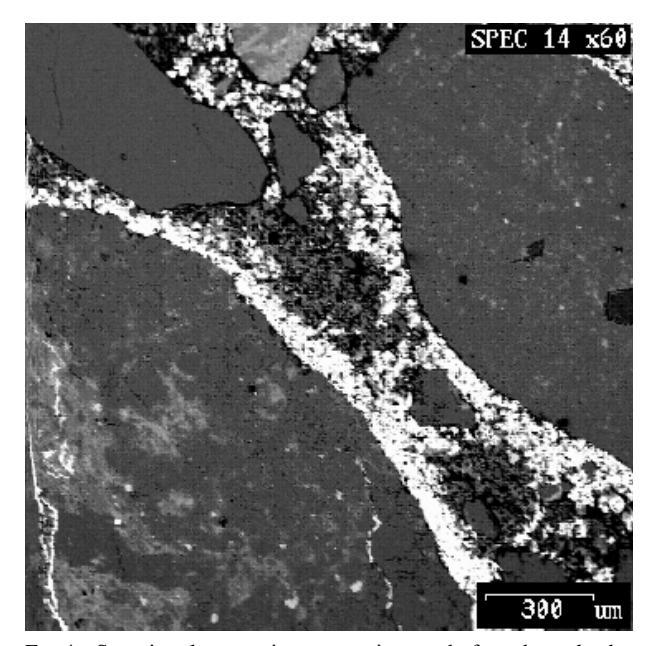
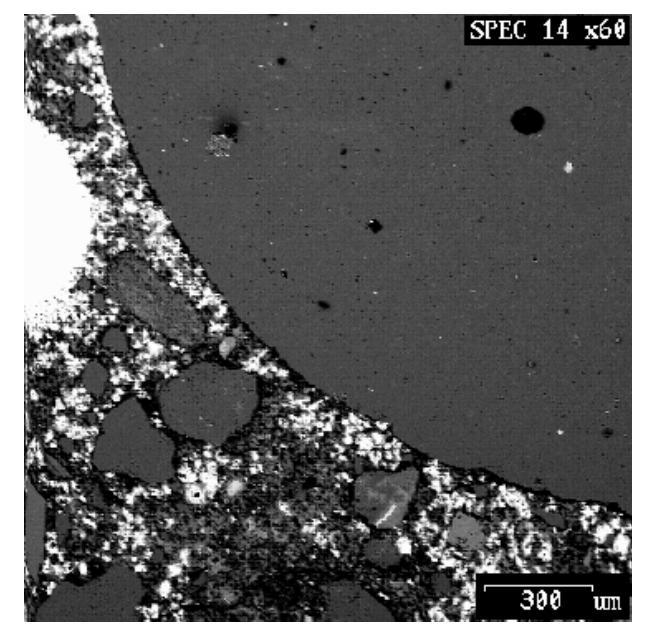
FIG. 4 Scanning electron microscopy micrographs from the no-load specimen.

Figure 4 shows typical images from the unloaded specimen. To restrain the specimen during the impregnation with Wood's metal, it was subjected to a small load of 10 MPa. In this specimen, the bright areas which have been permeated by Wood's metal correspond to regions of connected pores or microcracks. It is important to note that concrete is inherently cracked even before the application of any load (Hsu *et al.* 1963). Existing preload cracks are due to factors such as bleeding, creep, drying shrinkage, and so forth. However, there are no long cracks characteristic of stress-induced cracking.

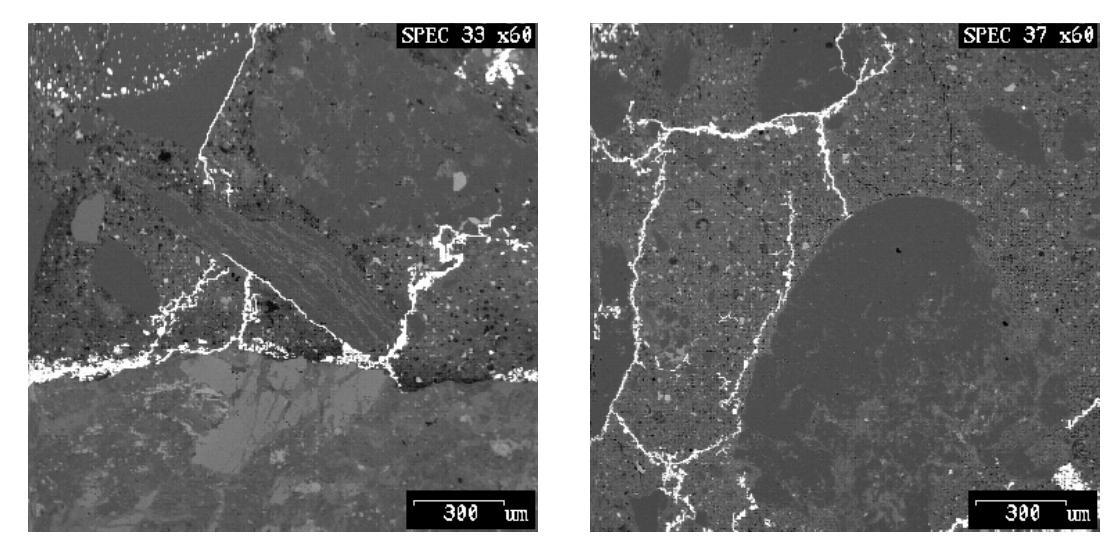
FIG. 5 Scanning electron microscopy micrographs from the laterally confined specimen.

The microcracks in the rest of the specimens appear to have been generated by several different mechanisms. Figure 5 shows two micrographs taken from a specimen under laterally confined condition. As can be seen, microcracks propagate through the cement paste and along the transition zone, which is the interface between the aggregate and the cement paste.

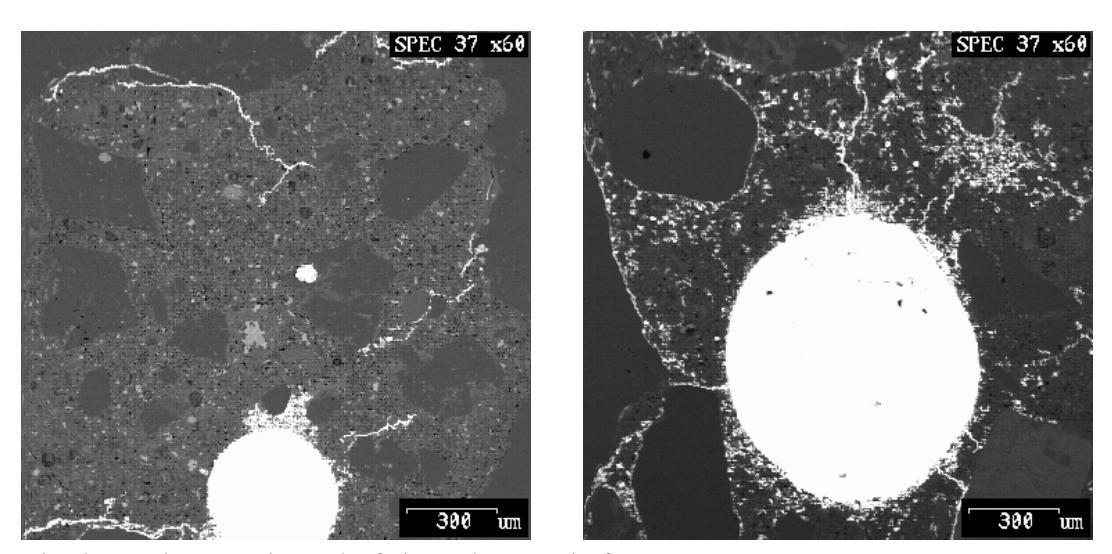
$\label{eq:Fig.6} Fig. 6 \quad \mbox{Scanning electron microscopy micrographs of microcracks propagating from a pore.}$

Many cracks were generated from voids. Figure 6 shows a micrograph of microcracks generated from a pore space, which is filled with Wood's metal. These microcracks were generated as a result of local tensile stress tangential to the boundary of voids, with a value that was of the order of the maximum applied principal stress. It was found that these cracks usually start from the pore boundaries and then propagate in the direction of maximum compression.

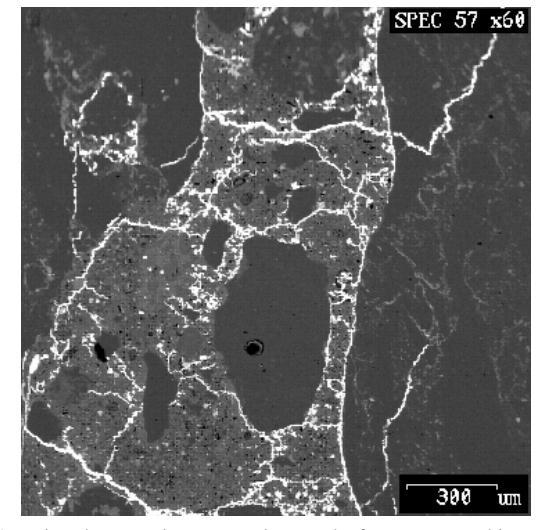
FIG. 7 Scanning electron microscopy micrograph of aggregate cracking.

Microcracks were also found to have been generated from the inside of aggregates, in a manner similar to a Brazilian test, when the aggregates were loaded across their height. Figure 7 shows a micrograph of this phenomenon.

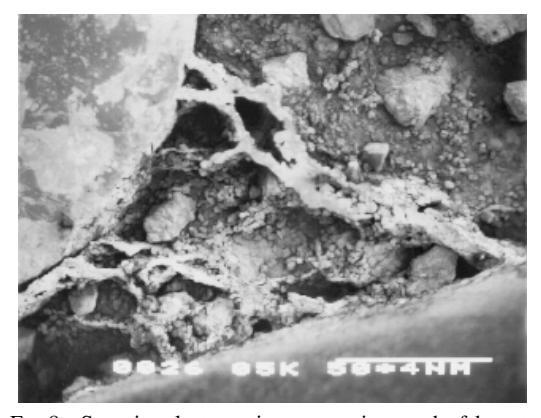
FIG. 8 Scanning electron microscopy micrograph of the network of fractures in three-dimensional form.

By submerging the specimens in acid, the network of fractures in concrete can be observed in three-dimensional form, as shown in Figure 8.
